Manhole Inspection Summary

Manhole # S13UU_013MH

Insp Date: **8/6/07 12:14 PM**

Location Address: **3051 LIBERTY HEIGHTS AVE** Cross Street: **WABASH AVE**

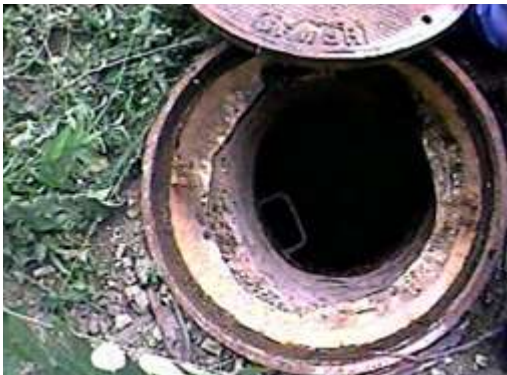
Top View

UNKNOWN PIPE TRAVERSING MANHOLE

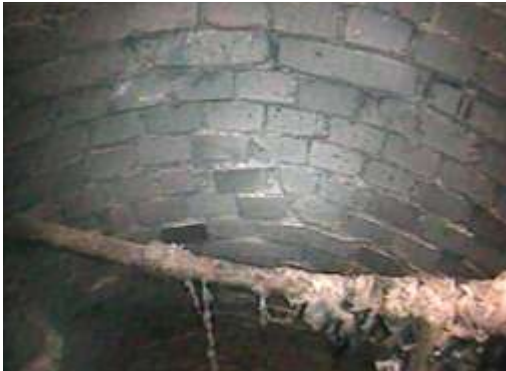
Defect 2

UNKNOWN PIPE

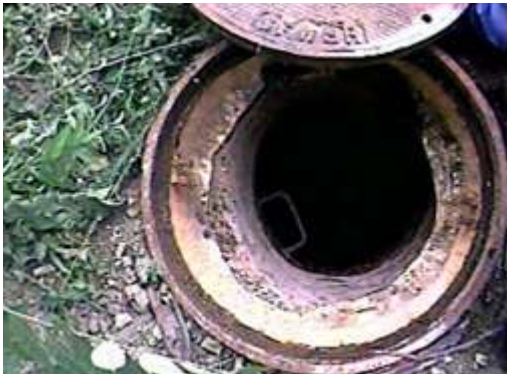
Defect 1

Frame Offset: **4** (in.) Condition: ☒ Sound ☐ Cracked ☐ Leaks

FRAME OFFSET

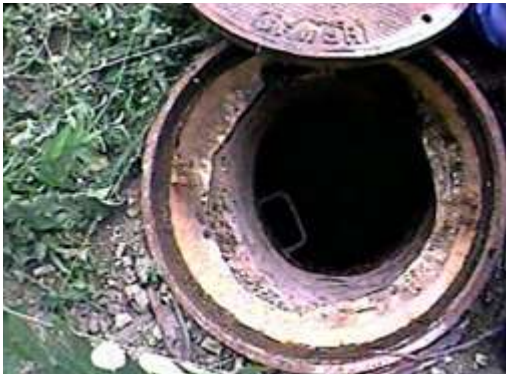
Chimney / Frame Adjustment ☒ Exists Material: **Brick** ☐ Parged Height: **15** (in.)
Condition: ☐ Sound ☐ Cracked ☐ Root Intrusion ☒ **Loose Brick** ☒ **Deteriorated**
Infiltration: ☒ None ☐ Joint ☐ Cracks ☐ Mortar ☐ Roots ☐ Wall

LOOSE BRICKS AND DETERIORATED AT FRAME ADJUSTMENT

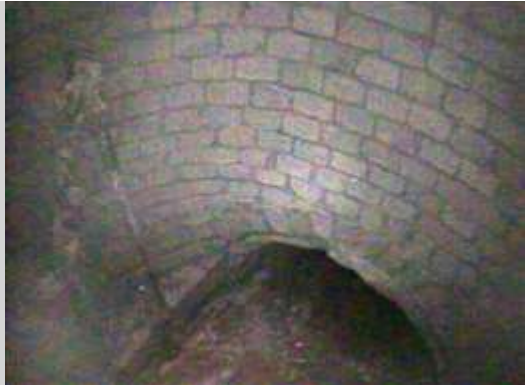
12 O'Clock Outflow

24 in. Circular Gravity Sewer
Pipe Out @ 12 O'Clock

Pipe Height: (in.) Direct
Pipe Material: **PVC** ☐ Pipe Lined
Invert Depth: **24.07** (ft.) Flow Characteristics: **Turbulent**
Deposits: ☒ None ☐ Mud ☐ Sludge ☐ Debris ☐ Grease
Silt Depth: (in.) Deposits Extent:
Infiltration: **None** Pipe Seal Cond: **Sound**

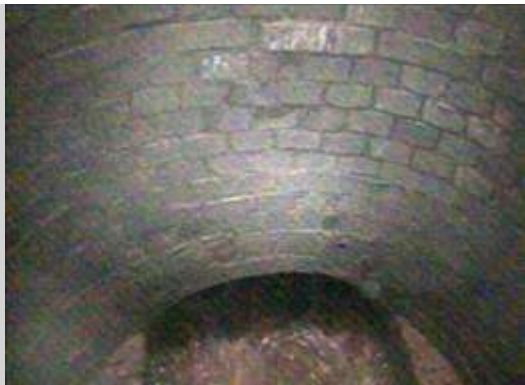
5 O'Clock Inflow

24 in. Circular Gravity Sewer
Pipe In @ 5 O'Clock

Pipe Height: (in.) Direct
Pipe Material: **PVC** ☐ Pipe Lined
Invert Depth: **24.04** (ft.) Flow Characteristics: **Turbulent**
Deposits: ☒ None ☐ Mud ☐ Sludge ☐ Debris ☐ Grease
Silt Depth: (in.) Deposits Extent:
Infiltration: **None** Pipe Seal Cond: **Sound**
